CALIFORNIA DIVISION OF MINES AND GEOLOGY
FAULT EVALUATION REPORT FER-245
SUPPLEMENT No.1

**SILVER STRAND FAULT, CORONADO FAULT, SPANISH BIGHT FAULT,
SAN DIEGO FAULT and DOWNTOWN GRABEN**
Southern Rose Canyon Fault Zone
San Diego, California

by
Jerome A. Treiman
April 22, 2003

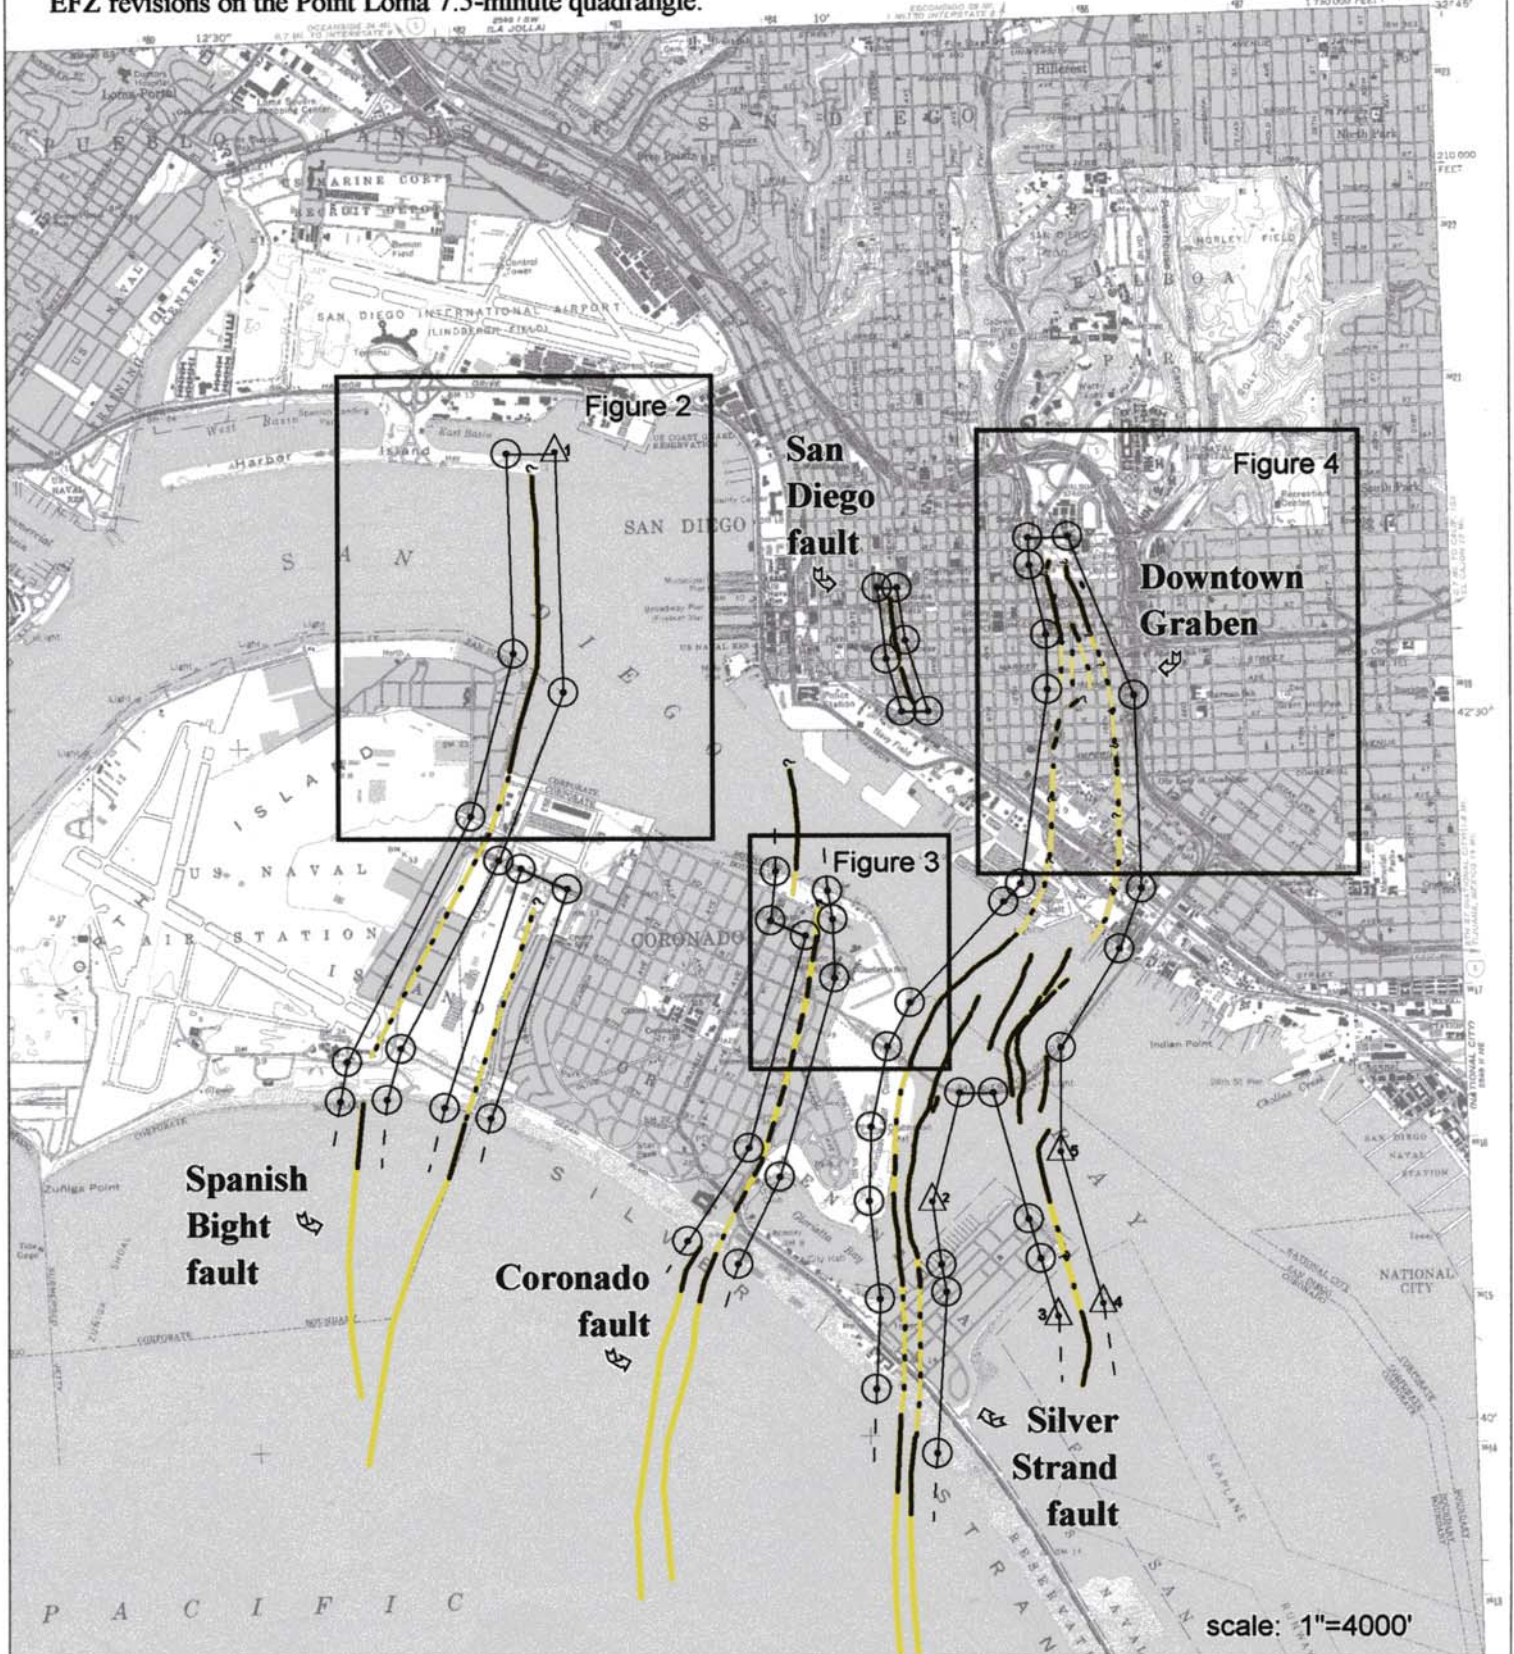
Index to areas for which comments were received relative to proposed EFZ revisions on the Point Loma 7.5-minute quadrangle.

POINT LOMA QUADRANGLE
CALIFORNIA-SAN DIEGO CO.
7.5 MINUTE SERIES (TOPOGRAPHIC)

The purpose of this supplement is to respond to comments received during the official review period for the proposed Earthquake Fault Zone revisions recommended in Fault Evaluation Report 245 (Treiman, 2002) and portrayed on the Preliminary Review map of the Point Loma quadrangle released on November 1, 2002. Relevant to this proposed zoning, we received three communications through the State Mining and Geology Board, as summarized on Table 1. In addition we received one further communication from the Port of San Diego (copy attached as Appendix A) and a report by Robert Prater Associates (2000) regarding a small fault in the downtown graben. Affected areas are indexed on Figure 1.
